# *Talbot County Creekwatchers*

## WATER QUALITY MONITORING REPORT

### 2001 – 2003

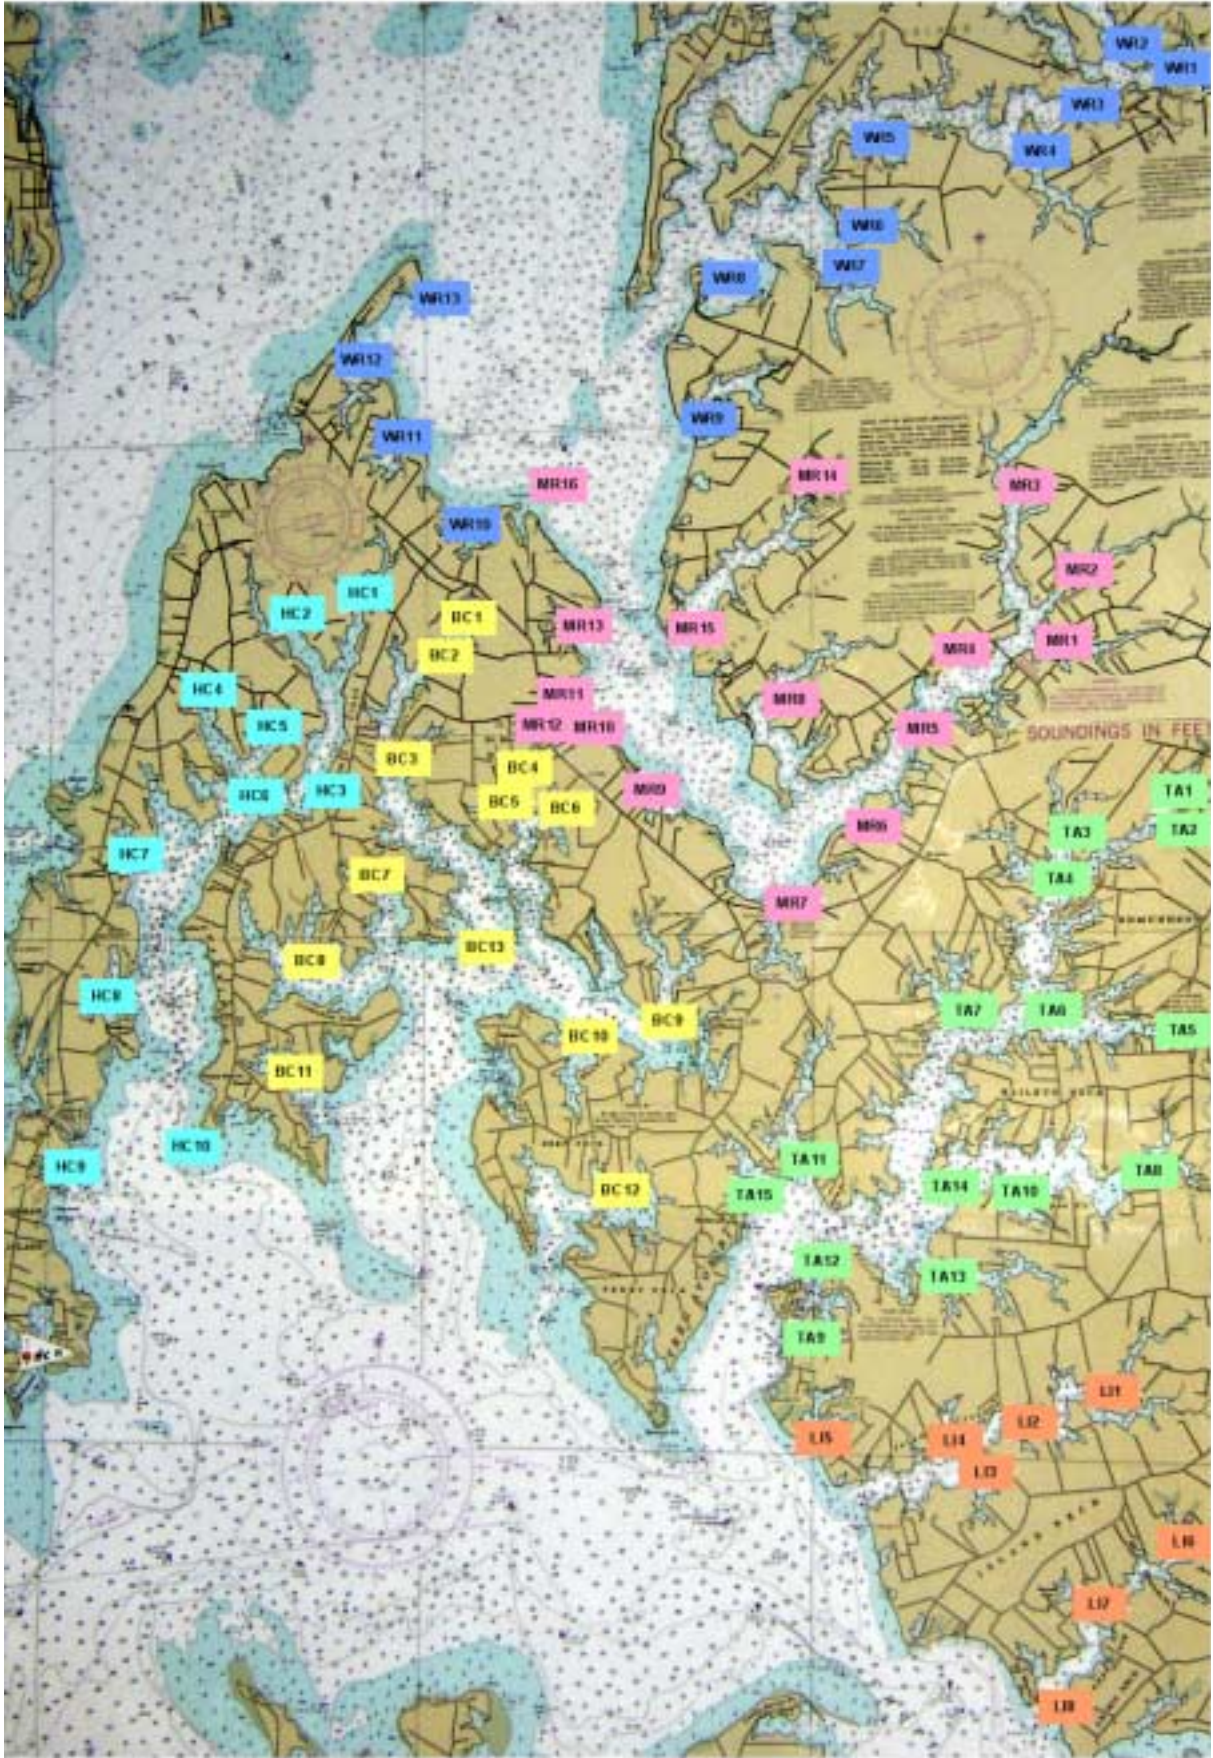
sampling site locations was generated (Appendix 3) and latitude/longitude coordinates were obtained for each site using GPS technology (Appendix 2).
